**First Scientific Conference
For Marine Science Technology
16 - 17 / 12 / 2019 Sabratha - Libya**

Corrosion Damage of Steel of Floating Oil Storage Tanks

Osama A. Terfas, Rayan T. Elsreti
Department of Marine and Offshore Engineering, University of Tripoli
o.terfas@uot.edu.ly

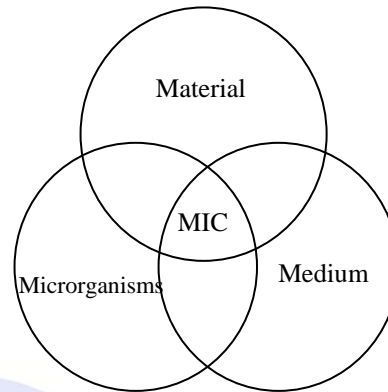
The typical electrochemical corrosion depends only on the material, and its chemical medium, however, in SRB-MIC a third element that is the microorganisms in the biofilm should be considered. Figure 1 shows the basic factors that lead to SRB-MIC [7].

Figure 1 Factors involved in SRB-MIC corrosion.

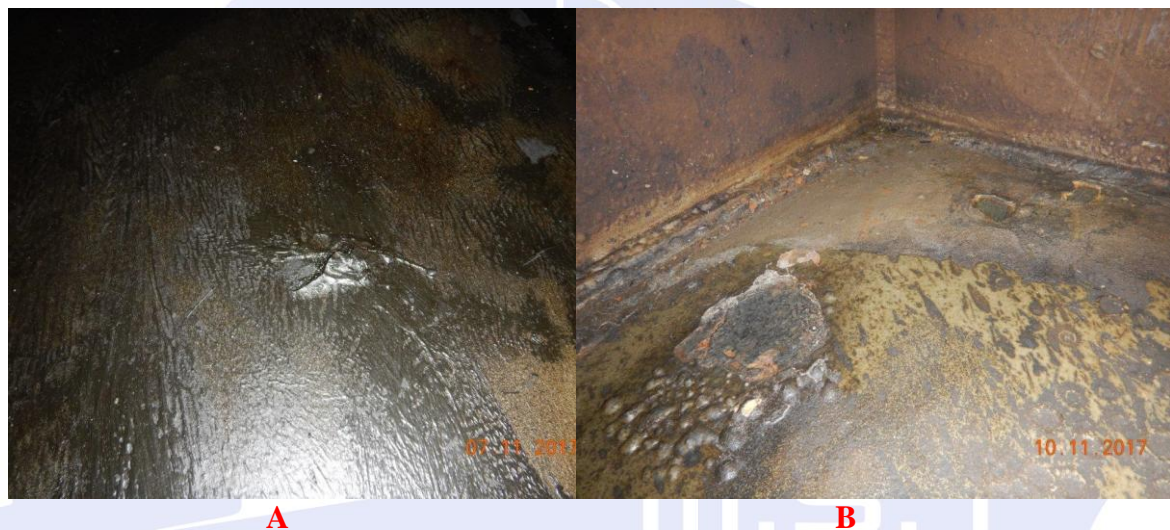
Figure 3-A shows a blisters and coating failure as the initiation process that leads to SRB corrosion. The black colour for the coating and steel surface is an evidence of the presence of the SRB corrosion causing bottom plate coating failure. Underneath blisters, oxidation occurred and steel become brown as shown in Fig 3-B. An evidence of the presence of Hydrogen Sulphid was also observed due to the brown colour and rotten eggs smells.

Figure 3 Coating failure due to the presence of the SRB on the bottom plate.

The high coating thickness and rapid curing of the coating, before evaporation of solvents results in excess solvent inside the coating. Later, when the solvent evaporated, this caused a material loss leading to contraction and stress inside the coating. In addition a high coating film thickness amplified the effect. The stress may result in cracking, or cause the coating to loosen from concave shaped surfaces. Underneath the loosened coating, pitting corrosion with up to 10 to 15 percent wall thickness reduction was observed. It is believed that the pitting was initiated by Sulphur Reducing Bacteria (SRB).

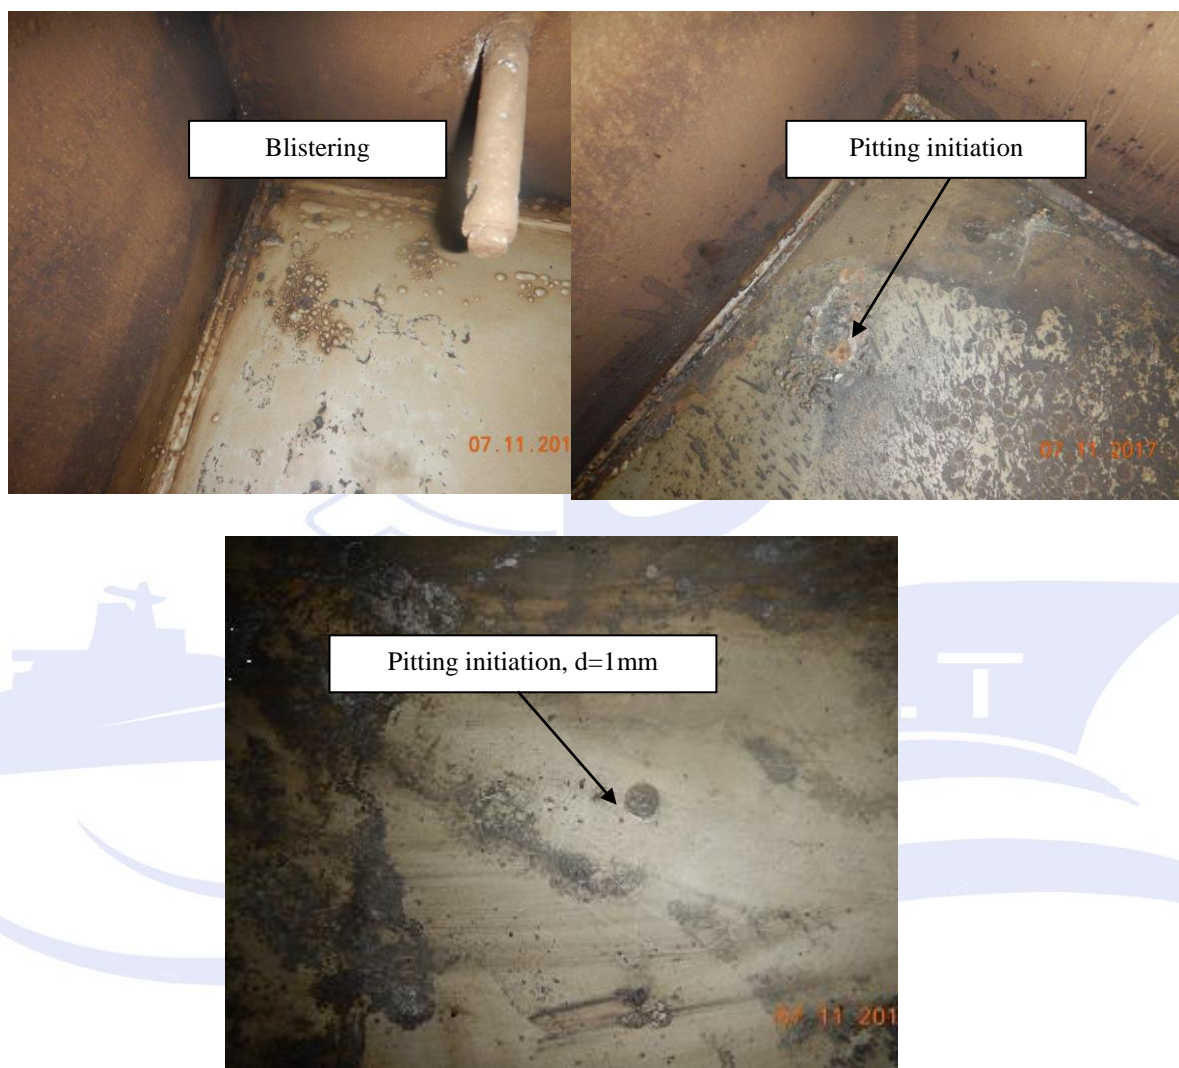
The SRB corrosion is observed as localized pitting under deposits that shield the organisms. The Damage is often characterized by pits in carbon steel as in Figures 4 and 5. The figures show blistering precedes the coating failure and initiation of pitting corrosion. This blistering occurred as a result of deficiency of coating binding to the tank surface which allows the crude oil contents to react or enter in the coating-surface interface at weak positions of the coating. The presence of the SRB that produces sulfate can be the cause which reacts hydrogen leading to chemical compounds as H_2S that react with the steel to produce ferrous sulphides or ferrous hydroxyl, eventually causing metal loss in the form of pitting corrosion. The localized

pitting initiation observed varies between 1-3 mm in depth. Furthermore, these pittings can act as stress corrosion cracking (SCC) initiator; because the “roots” of pits act as “stress magnifies” so that the applied stress becomes multiplied several times, resulting in stresses far more than the tensile yield strength, thus producing failure [7].

Figure 4 Initiation of pitting corrosion.

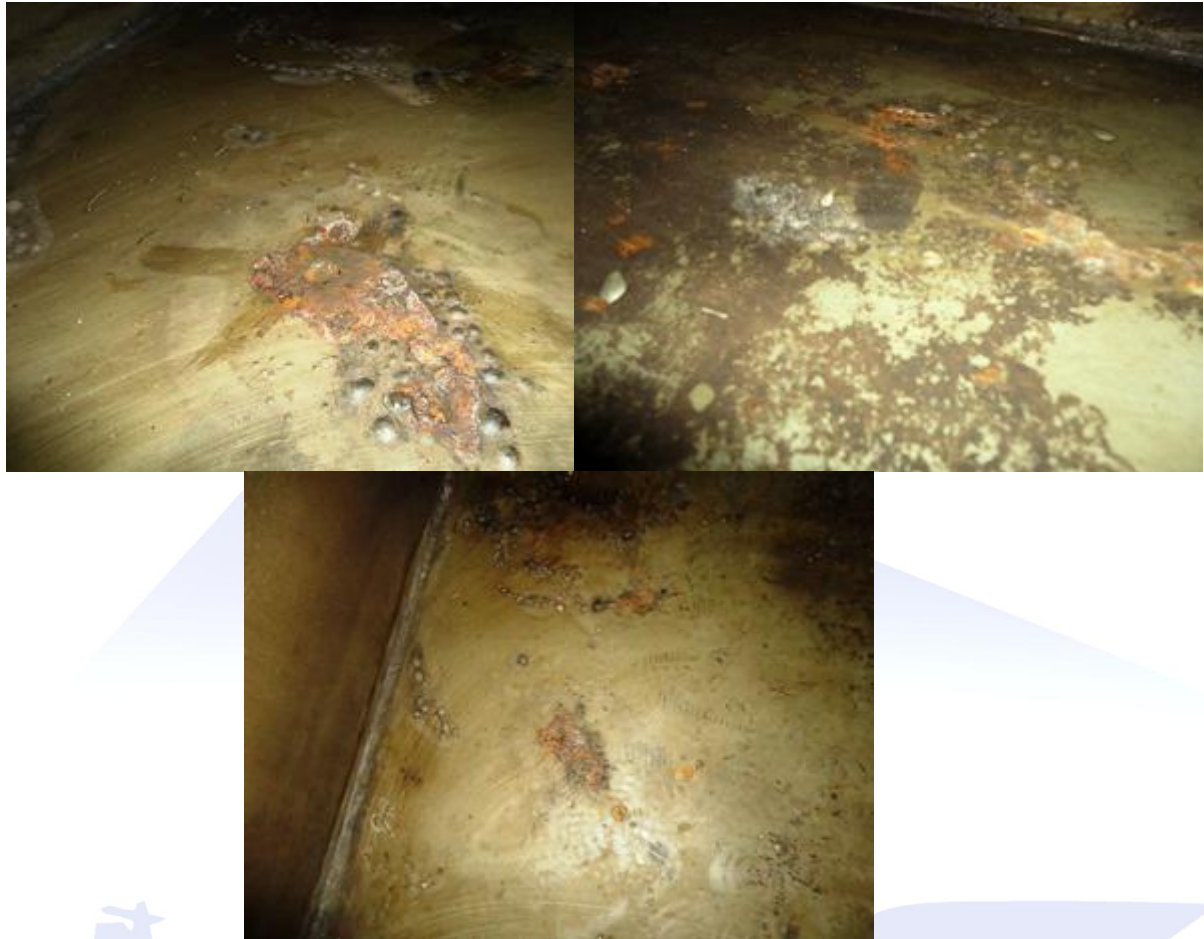
Figure 5 Coating defects and pitting corrosion.
